San Diego, CA
NOISE-CON 2019
2019 August 26-28

Case Study - Vibration Source Investigation in Large Semiconductor Fab Facility

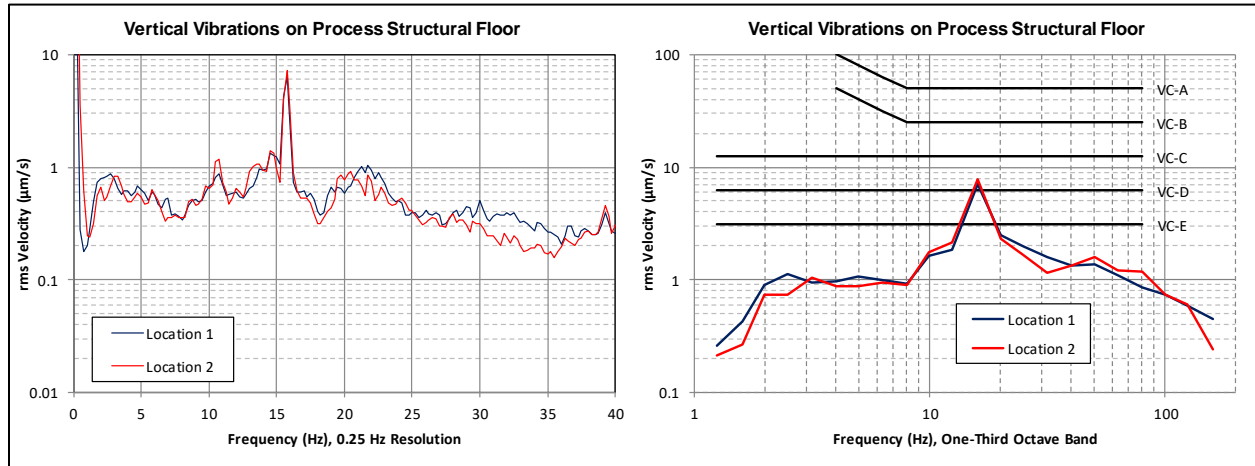
The 16 Hz tone is very clear in the narrowband spectra, and the 1/3 octave band spectra show that the vibrations exceed the VC-D threshold in the 16 Hz 1/3 octave band.

Figure 2: Vertical vibration spectra at two locations on the fab structural floor near the tool platform

The 16 Hz tone was first discovered while measuring vibrations on a tool platform and on the process floor directly below it. Figure 2 shows the narrowband and 1/3 octave band RMS vibration velocity spectra in the vertical axis at two locations on the structural floor near the tool platform.

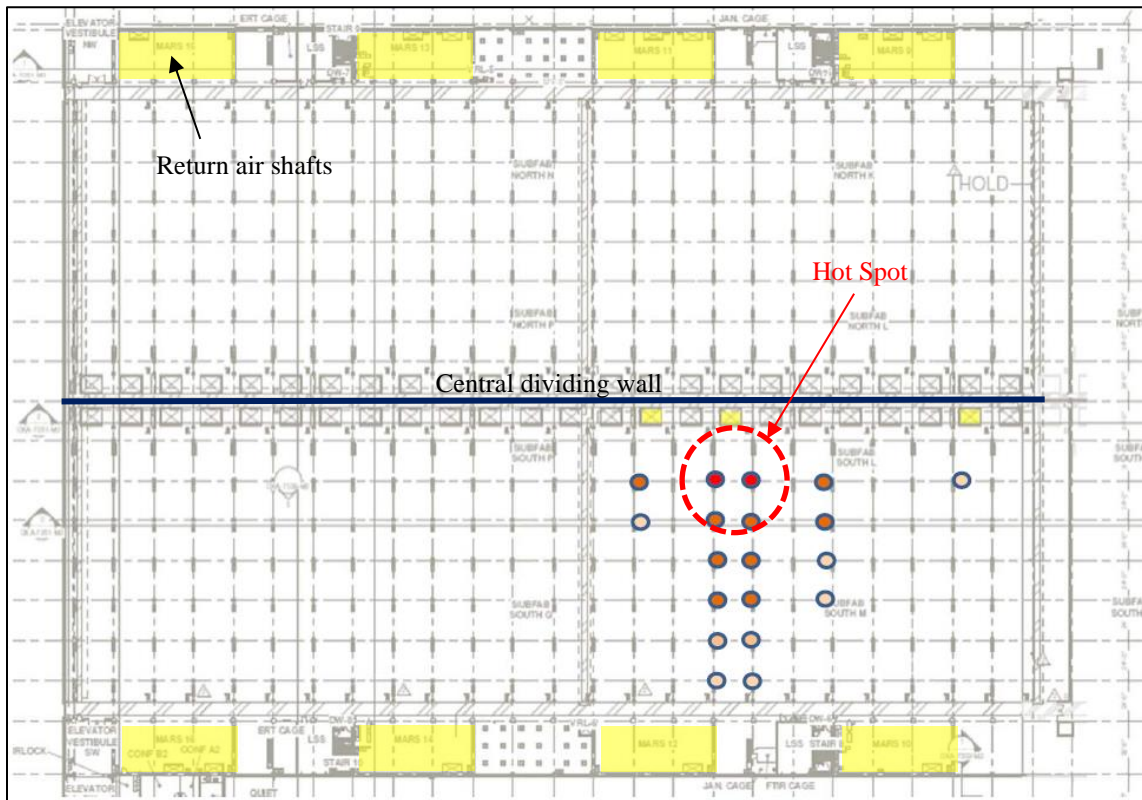
The same tonal vibration was also present on the subfab floor directly below. Additional measurements were carried out on the subfab level because it was easier to access; and a mapping of the severity of tonal vibration can be seen in the layout in Fig. 3. Here one can see that the tone was generally isolated to a few bays near the center of the building. Based on these measurements, we believed we had identified the “hot spot” for the vibration.

Figure 3: Vibration mapping of 16 Hz tonal impact. The color of the dots indicate the severity of the tone, with red being highest to white being lowest.

Interestingly, there were two other floor penetrations with similar partially open EXVO ducts nearby. These are shown as the small yellow boxes near the central dividing wall in Fig. 3. On these other two EXVO duct collars, we also measured very large 16 Hz tones. However, there was not a corresponding large 16 Hz tone on the subfab floor at those locations. The question then became: what is unique about the problematic penetration?

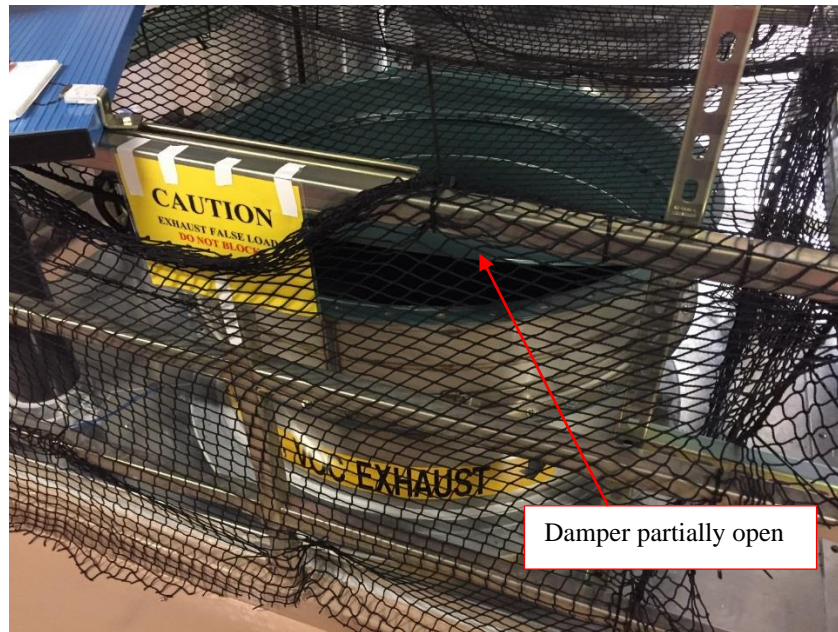
Figure 4: Photo of penetration, as seen on the subfab level. The EXVO duct terminates at this point with a partially opened damper.

What made the penetration in the “hot spot” unique was that the EXVO (volatile organic compound exhaust) duct, which terminated in the subfab, was not capped like in the adjacent penetrations. Instead, there was a damper (butterfly valve) which was partially open. This was done to exhaust air from the subfab and act as a temporary false load for the exhaust fans outside until the remaining ductwork upstream could be installed. This partial opening resulted in significant airflow noise and duct vibration. Measurements on the duct collar showed the 16 Hz tone as the dominant vibration on the duct. Measurements on the duct collars of the other two exhaust ducts at this penetration (EXGF and EXSC) did not show the 16 Hz tone as the largest tone. Therefore, at this point we believed we had at least found the system that was the source of the 16 Hz tone: the EXVO duct system.

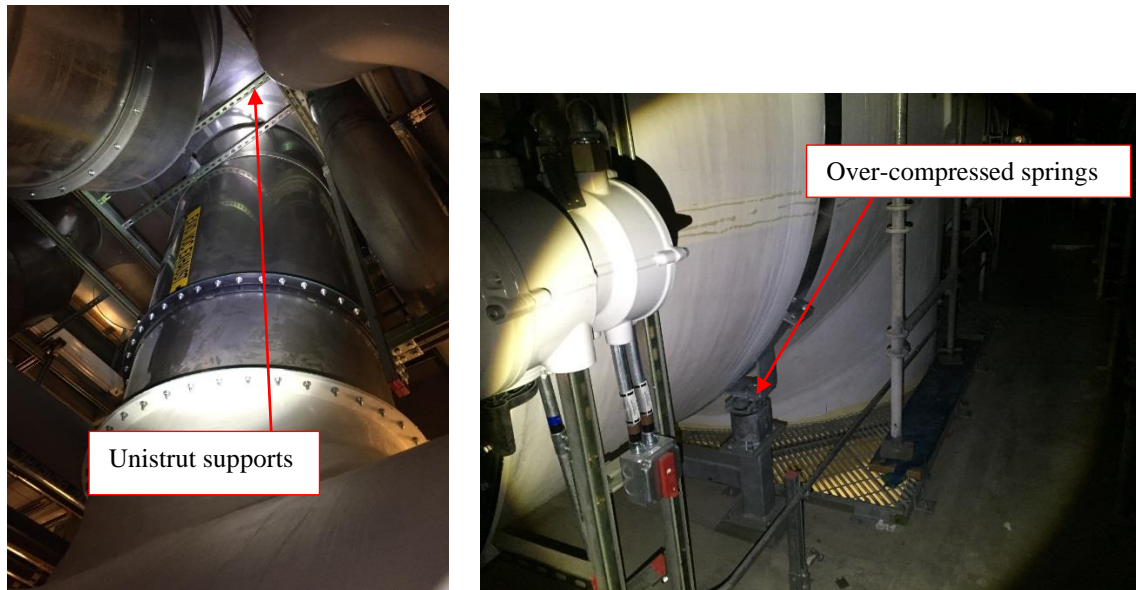
One element that may have been unique was the duct riser supports. Each duct riser is supported at the penetration by Unistrut framing underneath the floor slab. This framing is fabricated in the field, so each penetration could have slightly different conditions. Closer inspection of these Unistrut supports revealed that the duct risers were actually supported on spring hangers off of the Unistrut. At this particular “hot spot” penetration however, the springs had not yet been released so the duct was effectively being rigidly supported from the Unistrut.

Additionally, we found that on the utility level, there was a large T section in the main EXVO duct header directly below the problem area. The bottom section of the T leads into a tunnel which runs north and out of the building. This T section is supported on springs at each corner, and an inspection of these springs showed that they were bottomed out (i.e. over-compressed), so they were in effect, rigid supports as well. Figure 5 shows the Unistrut support and the T section spring supports.

Figure 5: Photos of Unistrut support (left) and of T section support(right).

It became very clear then that the large 16 Hz vibrations on the EXVO duct were being transmitted to the utility and subfab floor structures due to the poor condition of the spring isolators. The springs were ultimately re-adjusted, and this helped reduce the vibrations on the process floor. However, the vibration was still above the VC-D limit and we still did not know where the 16 Hz tone originated from at this point.

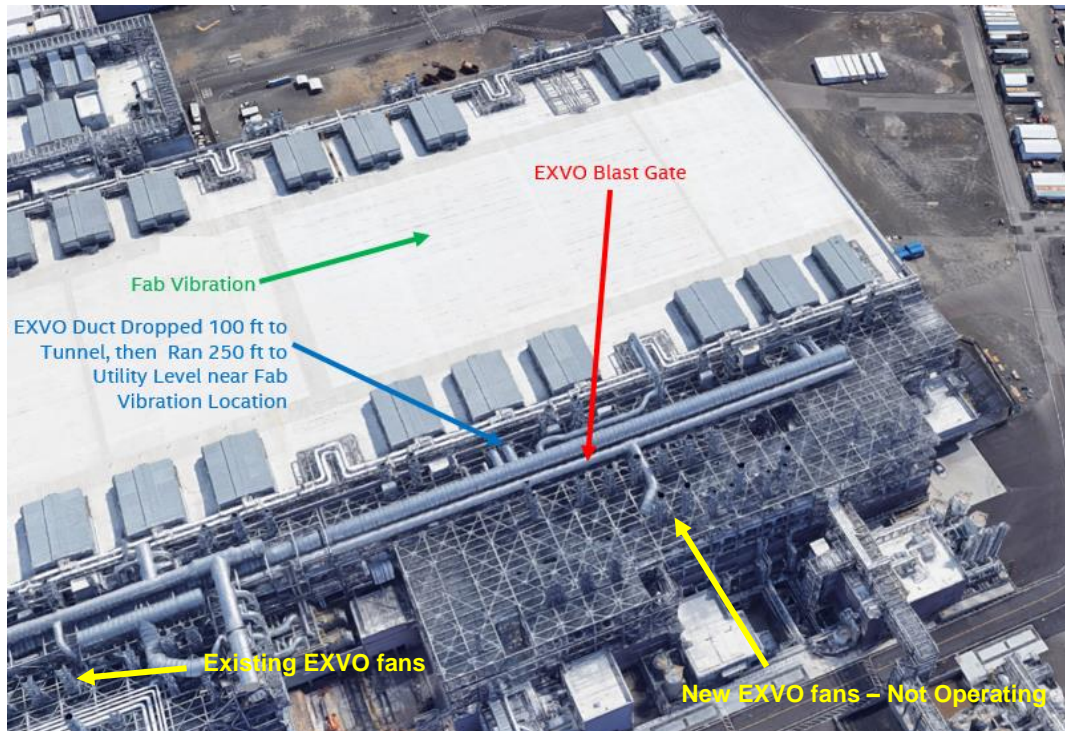
The steel support structure was of particular interest because this is where all of the large exhaust fans are located. The EXVO fans serving this portion of the building were not online yet at the time of the investigation, so this problematic EXVO duct was connected to a header that led to an existing set of operating EXVO fans at the east end of the steel support structure as shown in Fig. 6. An experiment was carried out in which the fan speeds for two of these fans were adjusted (one increased and one decreased) to see if we could affect a change in the 16 Hz vibration on the process floor and this was found to have no effect.

Figure 6: Photo of factory and adjacent but structurally independent steel support structure.

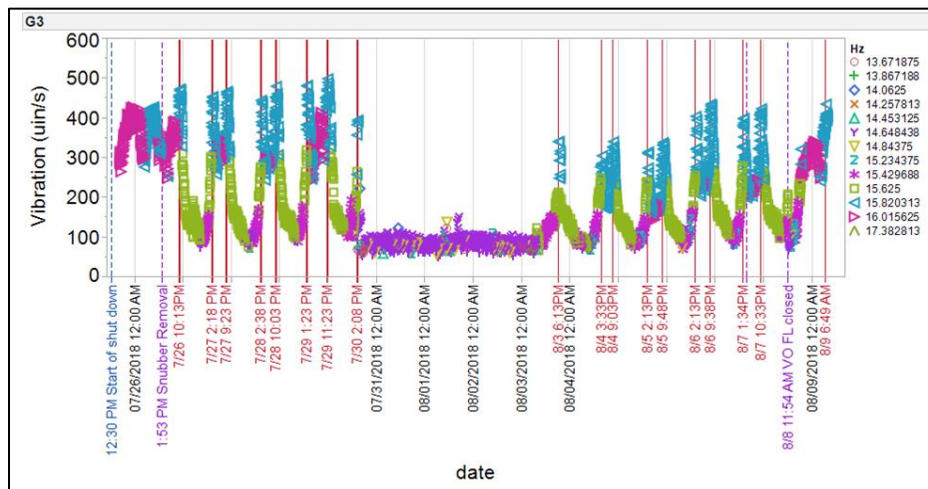
Focus then shifted to an examination of all of the other moving parts, including dampers and blast gates in this EXVO duct system. First, the dampers throughout the system inside the factory were measured and varied, with no change in vibration response. Finally, attention turned to the blast gate on top of the steel structure shown in Fig. 6. The blast gate separated two sections of duct from each other – one was live (at lower than atmospheric pressure, to draw exhaust out of the factory) while the other was not. Continuous vibration monitoring was set up on the process floor and it was found that the amplitude of the 16 Hz tone changed throughout the day on most days, producing a distinct diurnal cycle; however, there were also times that the tone disappeared completely as seen in Fig. 7. The times of the disappearance of the tone correlated to a change in

fan setup that resulted in a balance in pressure on both sides of the blast gate. Therefore, it was time to take a closer look at the blast gate.

Figure 7: Variation in factory floor vibration over time.

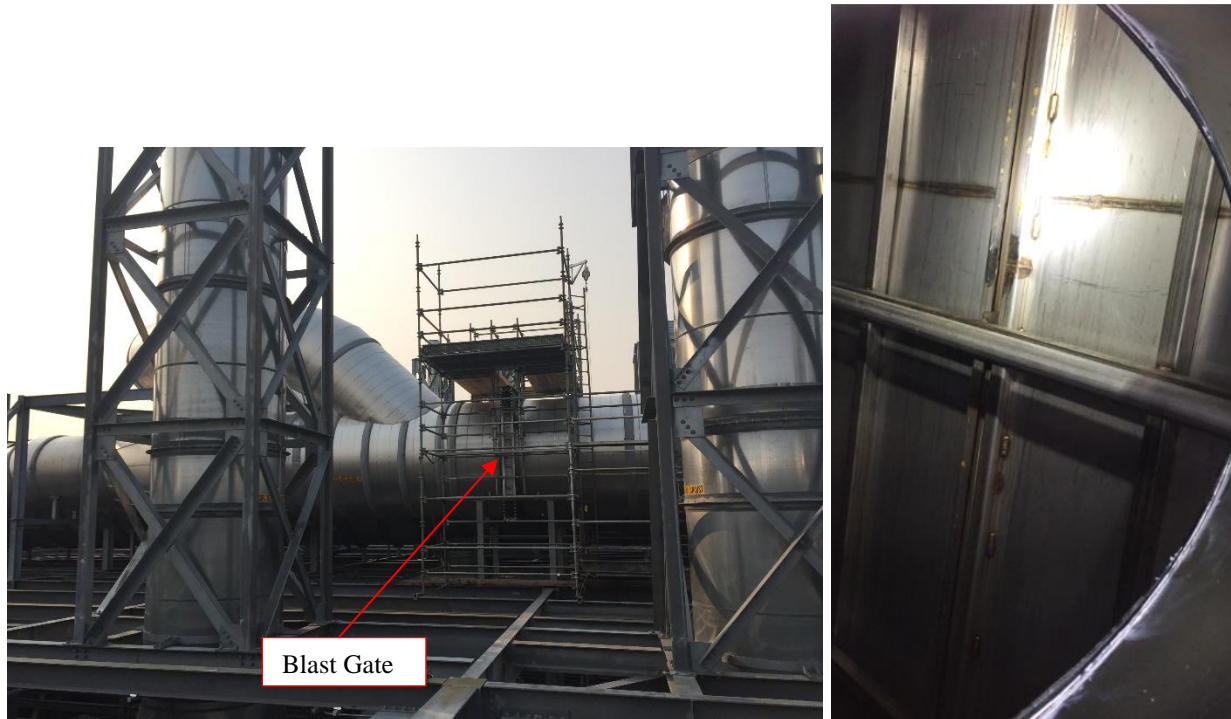
Scaffolding was erected on the top level of the steel structure, allowing access to the blast gate as shown in Fig. 8. Once at the level of the blast gate, a loud rattling sound was evident that was not previously perceptible from below, due to nearby fans whose noise masked the blast gate rattling. Upon measuring the blast gate vibration, the 16 Hz tone was present in the largest magnitude measured throughout the entire investigation – over 2500 $\mu\text{m/s}$. The gate rattling decreased significantly when the pressure imbalance on the two sides was equalized. This vibration would

Figure 8: Overview of scaffold around blast gate (left); internal view of blast gate in support frame (right).

ultimately be eliminated by inserting shims between the blast gate and the support frame so that there would be no travel in the blast gate during times of unequal pressure.
