# Evaluating and Modifying Existing Building Structures for Vibration-Sensitive Applications

Steven Lank, Hal Amick Ph.D. P.E.

Colin Gordon Associates

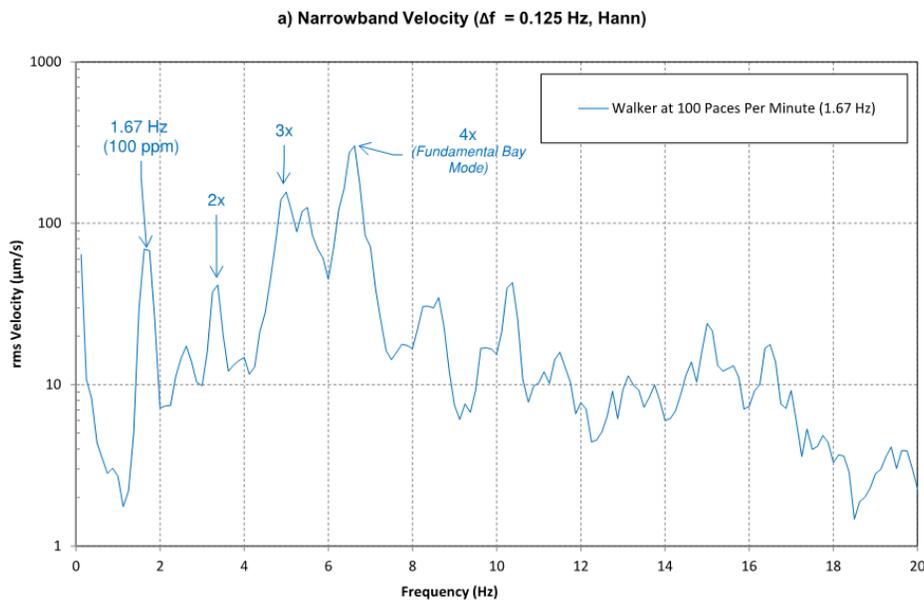
Figure 1: FFT spectrum of a person walking at 100 paces/min (ppm) through a 14.3 x 10m structural bay with a 6.6 Hz fundamental resonance frequency. Integer multiples of the walker pace rate, corresponding with peaks in the vibration spectrum, are indicated.

Floor vibrations are generated when a person walks on the floor because the load due to the walker varies with time. It consists of an initial pulse as the heel strikes, then a plateau as the weight transitions to the front of the foot as the person moves forward, then a drop-off as the foot is lifted to take the next step. For vibration-sensitive facilities, floor vibrations due to walkers are typically evaluated in the frequency domain, in large part because most criteria for vibration-sensitive instruments, as well as the typical generic VC criteria intended to represent various classes of sensitive instruments[1], are defined as a function of frequency. Figure 1 shows an FFT velocity spectrum measured as a person walked repeatedly at 100 paces per minute (ppm) through a 14.3m x 10m structural bay. A characteristic of any repeated-impact spectrum is that it will exhibit response peaks at the impact rate and integer multiples thereof, as well as a major peak at the fundamental resonance frequency of the structure being impacted (in this case, the floor). In this case, we see a peak at the pace rate of 1.67 Hz, and the x2 through x4 multiples. The x4 multiple in this case approximately corresponds to this floor’s fundamental resonance frequency of 6.7 Hz.

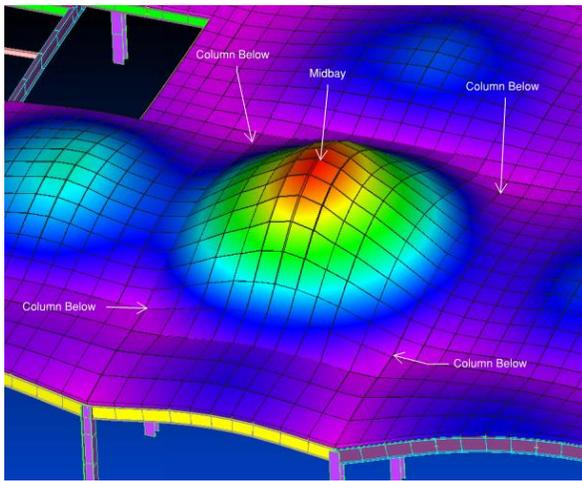
Figure 2: Isometric view of finite element model of a typical structural floor, showing the deformed shape of a typical floor bay at its fundamental resonance frequency

Importantly, the highest vibration amplitudes generated by a person walking on floors of the type discussed in this study tend to occur at the fundamental vertical resonance of the structural floor bay<sup>2</sup> where the walker and receiver are located. The typical deformed shape at the fundamental resonance of a conventionally framed, rectangular floor bay – extracted from a finite element model of a floor structure – is shown in Figure 2. The highest amplitude response occurs at the least stiff portion of the bay – the point furthest from all the surrounding columns, or the “midbay”. Lower resonance frequencies may be predicted via modeling that encompass more than one bay; however, field studies have shown that those modes generally are not excited by typical walkers.[2] Higher modes can be excited by walkers, however amplitudes at those frequencies tend to be significantly lower. Reducing the walker-induced vibration amplitudes occurring at the fundamental resonance frequency of the bay, particularly at the midbay, was therefore the primary focus of the case studies discussed below.<sup>3</sup>

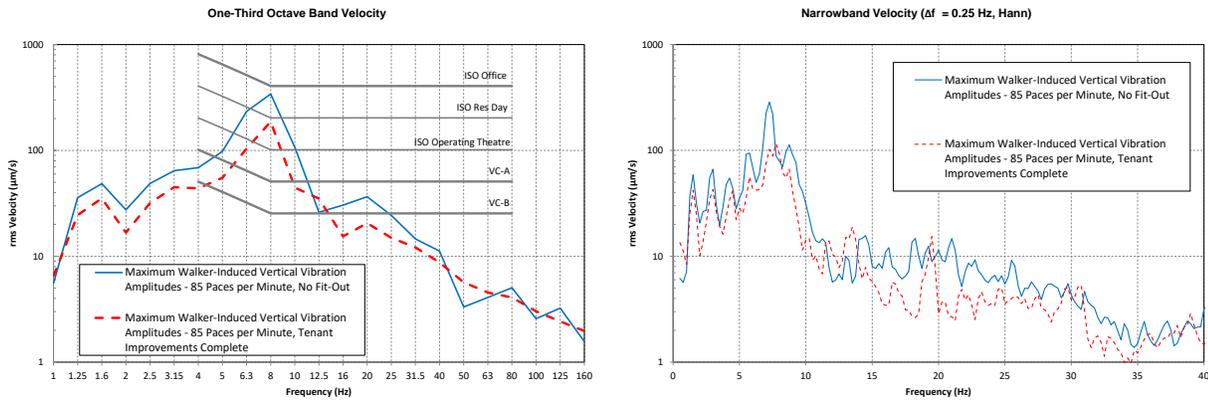
Figure 3: Walker-induced vibration amplitudes in typical wet lab – before and after tenant improvement works.

Figure 3 shows walker-induced vibration amplitudes measured in the Case 1 facility at the same location with the same individual walker, walking location, and walker pace rate on two separate occasions under two conditions: core and shell

conditions and at the conclusion of the tenant improvement work with all fit-out in place. Vibration amplitudes are shown from 1 to 160 Hz in one-third octave format, but only up to 40 Hz in narrowband FFT format – the latter to better illustrate the dynamics at the lower frequencies of interest. The fit-out in this case consisted primarily of typical fixed lab benches and case work, as well as mechanical ductwork and ceilings suspended below the slab. The fundamental bay resonance has not changed significantly between the two tests – which is as expected given that no additional stiffening elements were added to the floor structure. The highest vibration amplitude, however, is reduced by more than 2 times (> 6 dB), which is likely due in large part to the added damping provided by the fit-out. This is evident in the FFT spectrum on the right in Figure 3, where the sharp (high-Q) peak at the fundamental resonance at around 7.25 Hz measured under core and shell conditions has broadened and decreased significantly in amplitude once fit-out was completed.

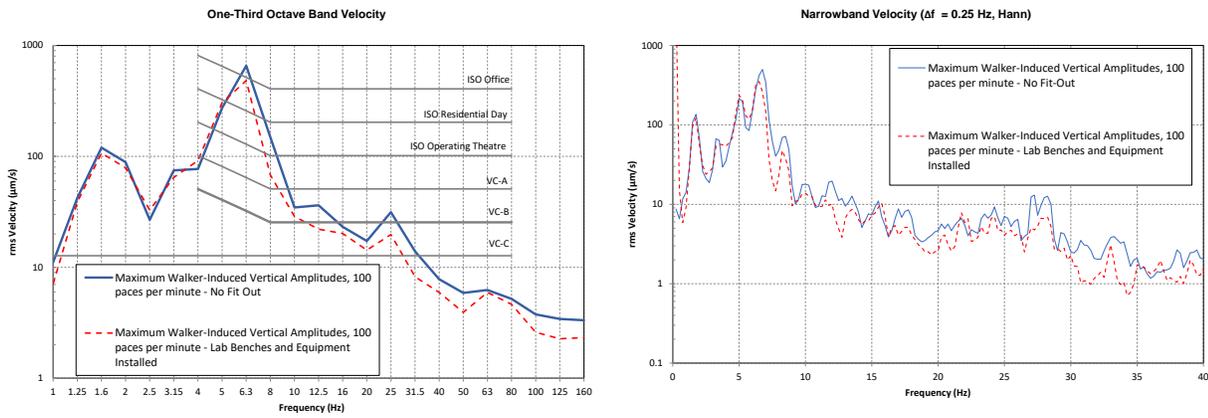
Figure 4: Case 2 - Walker-induced vibration amplitudes in identical structural bays – with and without fit-out.

The walker-induced vibration amplitudes in the two Case 2 Bays are shown in Figure 4. In this case, note that the difference in amplitudes with and without fit-out is small – with a reduction of only around 2 dB. Measurements of the damping at the fundamental resonance frequency in each bay showed 1.5% of critical damping in the fit-out bay compared to 1.0% in the bay without fit-out – a fairly minor increase of only 0.5% due to fit-out. The result is a relatively minor difference in maximum walker-induced vibration amplitudes between the two cases – with maximum amplitudes that are within typical expected measurement variability.

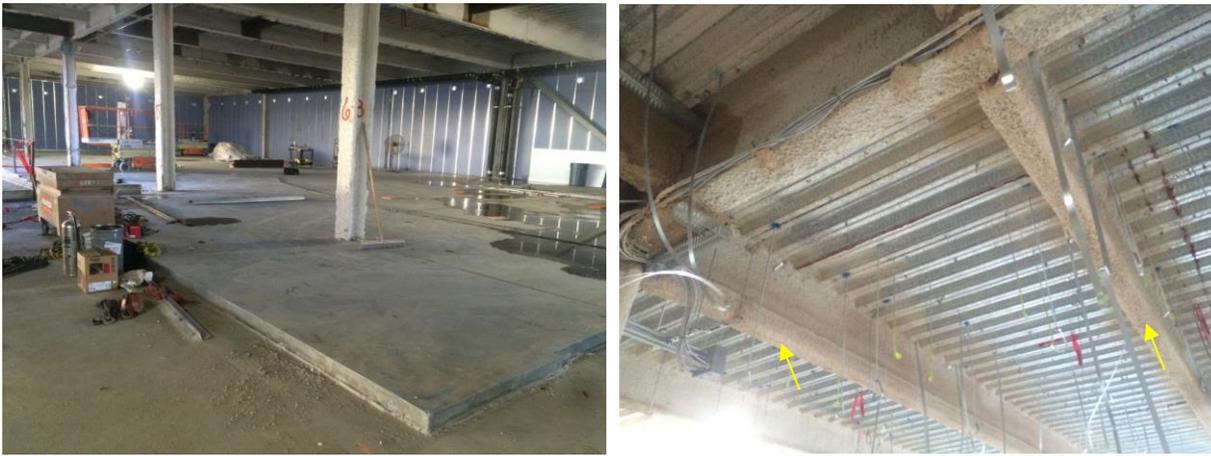
Figure 5: Case 3 – Photos of topping slab (left) and tube steel stiffeners from below (right, with fireproofing applied)

Case 3 involved a portion of the 4<sup>th</sup> floor of a building that was being fit out as a vibration-sensitive vivarium space for biology research, requiring VC-A (50 µm/s RMS) performance. The existing floor structure supporting the vivarium space utilized a one-way joist slab, with an 83mm lightweight concrete slab on a 76mm steel deck, framed with W21x44 joist beams spanning 12.8m and spaced of 2.4m on center, supported by W24x55 girders spanning 7.9m. Initial vibration measurements on this slab showed walker-induced amplitudes of up to around 2,000 µm/s RMS, around 40x (32 dB) higher than the VC-A criterion. Structural retrofits were proposed to reduce the vibration amplitudes, including tube-steel (HSS) elements welded beneath the existing steel beams supporting the floor, as well as an additional 100mm topping slab installed atop the existing slab. Photos of the topping slab and stiffening steel are shown in Figure 5.

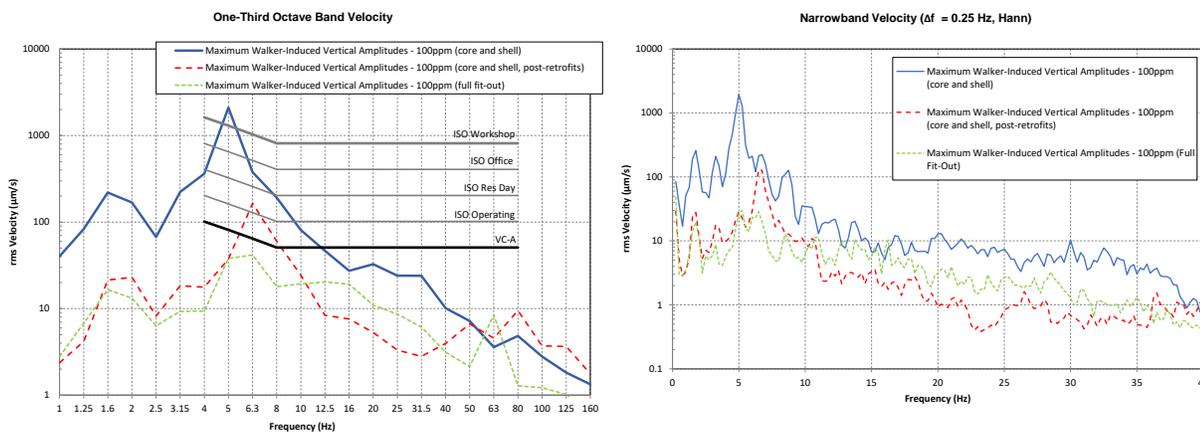
Figure 6: Case 3 - Walker-induced vibration amplitudes at the same location 4<sup>th</sup> floor vivarium space at various stages of completion. Walker at 100 paces per minute through the middle of the structural bay in all cases.

Figure 6 shows walker-induced vibration amplitudes measured as part of Case 3. Measured vibration amplitudes at a single location on the floor are shown for three separate conditions: core and shell, core and shell with structural retrofits installed, and with the final fit-out complete. The results show that the structural retrofits reduced the maximum walker-induced amplitudes by roughly 10 times (20 dB), significantly increasing the fundamental resonance frequency of the floor as well. Notably, the added stiffness from the retrofits reduces the amplitudes at nearly all frequencies, including at low frequencies around the walker pace rate. Walker-induced amplitudes are further reduced around the bay resonance once the partitions, ceilings, casework, and other fit-out are installed – with the final conditions meeting the VC-A criterion.

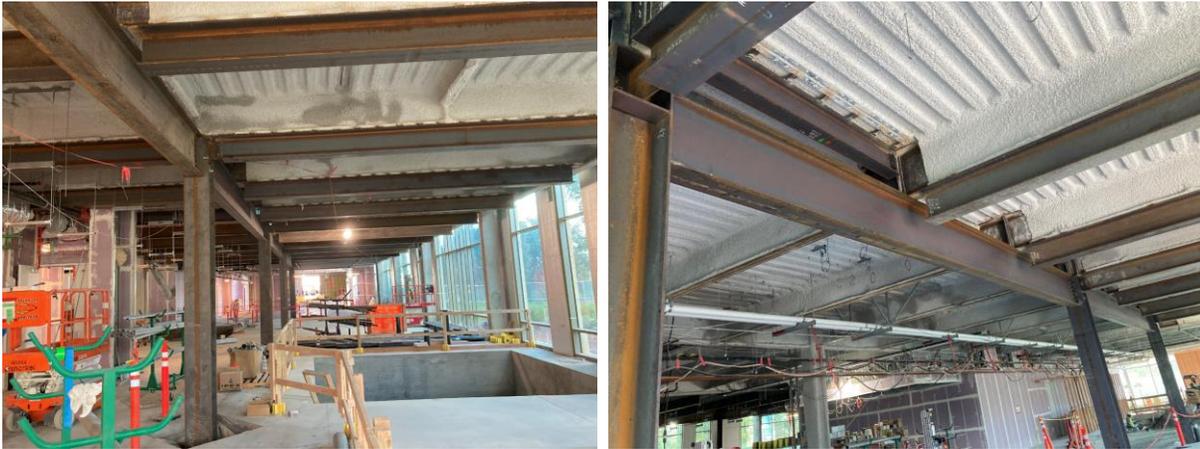
Figure 7: Case 4 – Stiffening steel and new columns and girders.

Structural retrofits were implemented to reduce the floor vibration amplitudes, including WT stiffeners welded beneath all existing beams and girders, and an additional 100mm thick normal weight concrete topping slab was added. In this case, due in part to the relatively thin existing concrete slab, supplemental columns and a new girder were also required at the midspan of the existing beams to provide further stiffness. Example photos of the WT stiffeners welded to the underside of the existing beams, new columns, and new girders are shown in Figure 7. Notable, the number of structural bays that could be retrofitted was limited by the total mass of added concrete that could be added to the building without required seismic retrofits.

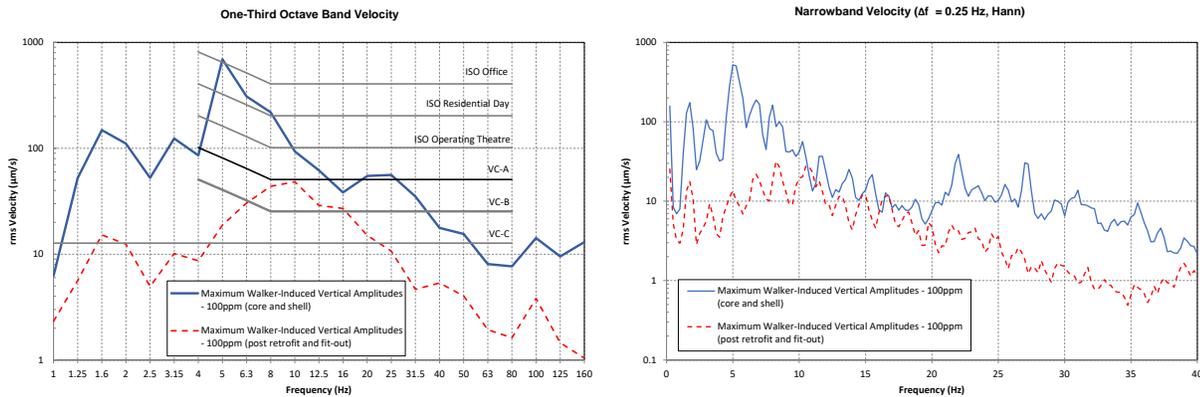
Figure 8: Case 4 - Walker-induced vibration amplitudes in 2<sup>nd</sup> Floor optics lab before and after retrofits and fit-out.

Figure 8 compares the walker-induced vibration amplitudes measured at a single location in Case 4 in the base core and shell conditions, as well as after structural retrofits and fit-out were complete. The combination of stiffening the floor and the added damping from fit-out in this case reduced the maximum walker-induced amplitudes by more than 14x (23 dB).

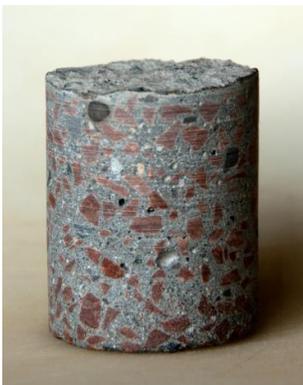
Figure 9: Core sample of 50mm concrete topping slab installed for Case 5 showing high-strength aggregate (brown).

concrete with minimum compressive strength of 99.3 MPa was utilized. The Young's modulus of the concrete, which is critical to the stiffness of the bay and therefore vibration performance, was around 2x that of concrete used for the base building. Achieving this concrete strength required the use of a low water-to-cement ratio along with special high-strength aggregate, which is visible in the core sample from the topping slab shown in Figure 9. An adequate bond between the existing slab and new topping slab, which is critical for shear transfer for low-amplitude vibration, was ensured by scoring the existing slab prior to pouring the new slab.

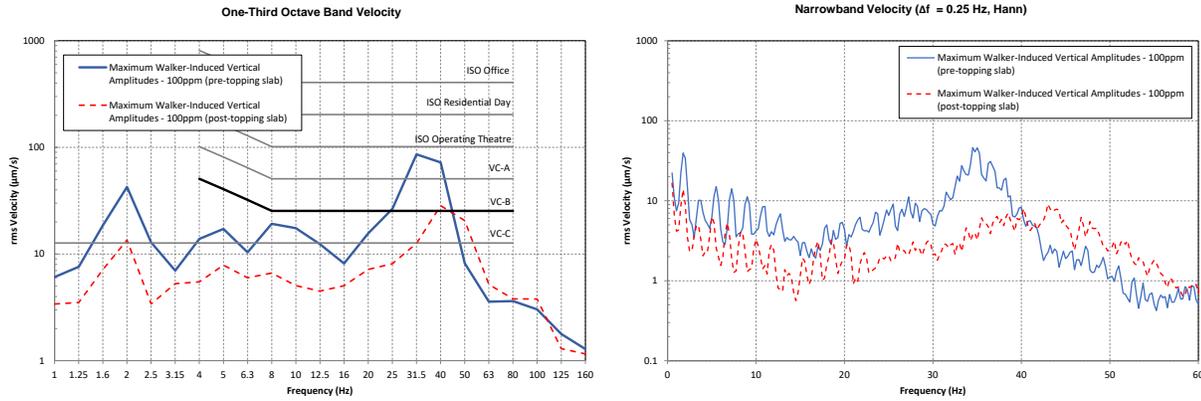
Figure 10: Case 5 – Measured walker-induced amplitudes before and after installation of high-strength topping slab

Vibration spectra due to a typical walker in an example location on the floor, measured before and after the installation of the topping slab, are shown in Figure 10. The addition of the topping slab reduces the maximum vibration amplitudes by around a factor of 4 (12 dB), meeting the VC-B criterion. The plots show that the fundamental resonance frequency of the bay increases somewhat with the addition of the topping slab, likely due to the added stiffness. The results shown are typical of the bays that were retrofitted, though it's notable that walker-induced vibration amplitudes were reduced by a factor of up to 6x in selected bay, with amplitudes as low as 7  $\mu\text{m/s}$ .

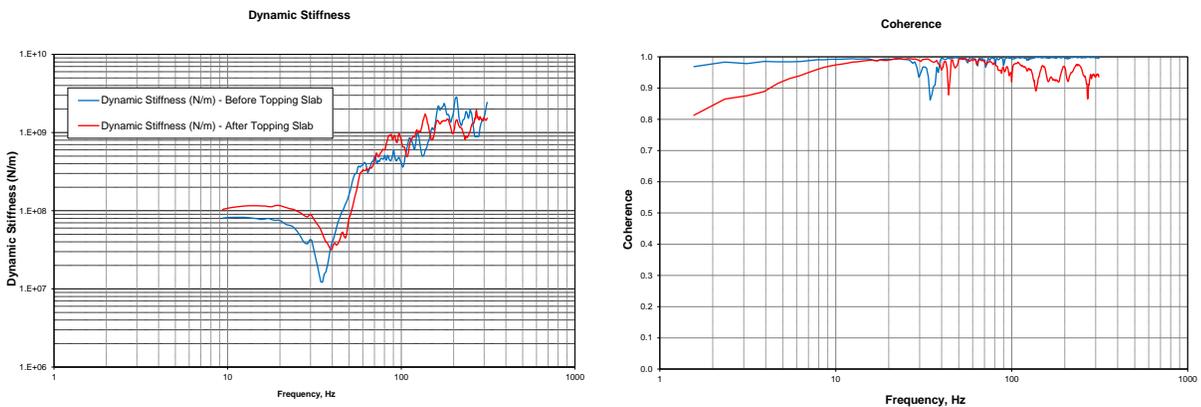
Figure 11: Case 5 – Measured dynamic stiffness and mobility before and after installation of topping slab

The peak in the frequency spectrum around the resonance frequency has a lower Q with the added topping slab, indicating that additional damping may have been introduced by the addition of the slab. The changes in dynamic performance are further illustrated by the dynamic stiffness measurement results at this location, shown in Figure 11. Note that the dynamic stiffness at frequencies well below the fundamental resonance frequency, which can generally be assumed to approximate the static stiffness, increases by around 3 dB. However, the dynamic stiffness at its lowest point (at the fundamental resonance frequency of the bay) increases by around 8 dB. In addition to added damping, this difference could be due in part to the repetitive floor structure in the subfab – where adjacent bays having the same thickness and column spans contribute to the dynamic response, due to similar or identical resonance frequencies. The application of the topping slab, which would have added a slightly different amount of mass to each floor bay depending upon the sizes of the individual penetrations, could result in greater differences in resonance frequencies between adjacent bays, resulting in a lower amplitude response at resonance. Regardless, the results show that the retrofit was successful in achieving the project vibration criterion.

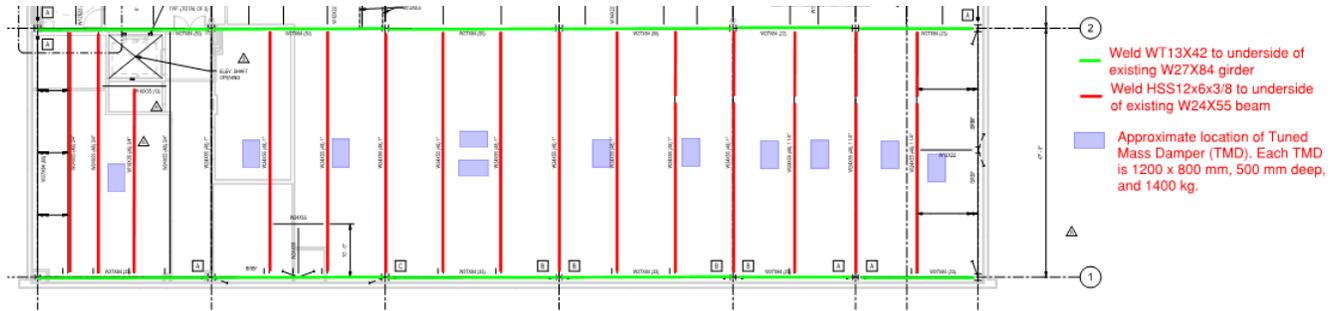
Figure 12: Case 6 – Level 2 structural framing plan showing location of new WT and HSS members and TMDs

TMD systems used to control floor vibration consist of a large mass, typically on the order of 2 to 10 percent of the mass of the floor bay, which is attached to the floor via a set of springs and dampers at the approximate location of maximum deformation at the frequency of concern – typically the middle of the structural bay, though not always. The system is designed and adjusted so when the floor is excited, the mass oscillates on the spring and damper system at the designed frequency – which is typically tuned to the fundamental resonance frequency of the floor bay. The oscillation of the mass dampens the vibration of the floor at resonance. Importantly, a tuned mass damper will only reduce the vibration amplitudes at the frequency it is tuned to. While vibration at the fundamental bay resonance is typically the worst case in terms of walker vibration, vibration amplitudes measured on the existing floors in this case exceeded the criterion at other frequencies as well – with amplitudes as high as roughly 200  $\mu\text{m/s}$  at lower frequencies, predominantly at the walker pace rate and the first few harmonics. A TMD would not be expected to reduce these amplitudes. The TMD will also have minimal impact on the frequency of the floor resonance, meaning that a TMD installation alone would still result in a floor with a relatively low frequency resonance that is easily excitable by walkers. For these reasons it was advisable to combine any TMD installation with structural retrofits that increase the bay stiffness at least somewhat, rather than try to rely on the TMD to provide all the necessary attenuation. The retrofit design including additional steel and added TMDs is shown as a markup of the base building structural drawings in Figure 12 below.

- In addition to impacting the fundamental resonance frequency, full-height partitions in the level below also impacted the fundamental mode shape within each bay. Figure 13 shows color contours illustrating the predicted deformed shape of one bay in the building (Bay 4, or the fourth bay from the left) which was to have a full-height partition below running north-south down the approximate middle of the structural bay. Note that the full-height partition serves to stiffen the middle of the bay, resulting in the highest deformation (the red area of the contours) occurring closer to the quarter bay – between the partition and the column line. Since the TMDs must be installed at the location of maximum deflection for the mode to which it is tuned for maximum benefit, this meant that the TMDs for this bay were shifted closer to the quarter bay rather than centered on the midbay as with other bays. Note that, as shown in Figure 12, similar considerations were required for the second bay from the left.

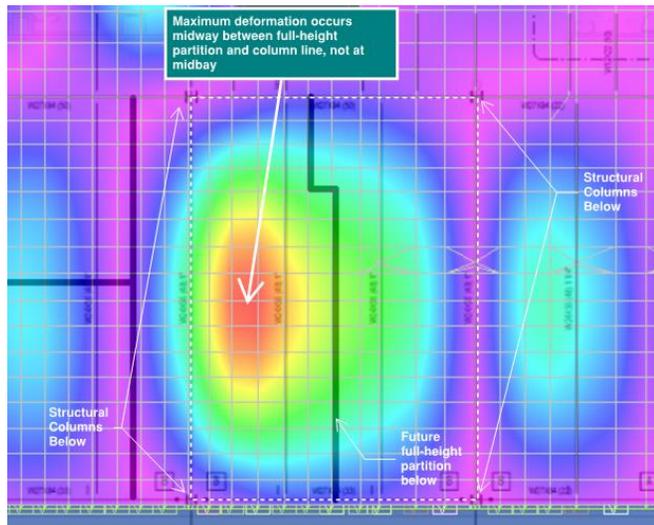
Figure 13: Case 6 – Deformed shape of fourth bay from the left at 7.2 Hz. Structural bay indicated as white dashed line.

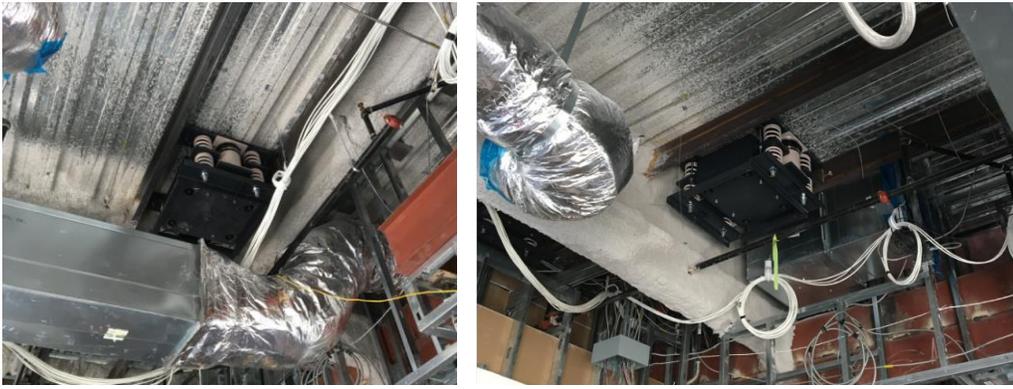
Figure 14: Case 6 – Tuned mass dampers mounted to the underside of the floor structure.

- The TMD installation involves adding significant weight to the underside of the floor structure. Two dampers were required in each bay in this case, each weighing approximately 1400 kg. The project structural engineer was required to confirm that the existing structure could support the new load, as well as work with the TMD manufacturer on the required details for attaching the TMD to the structure.

Photos of selected TMDs as installed on the underside of the structure are shown in Figure 14.

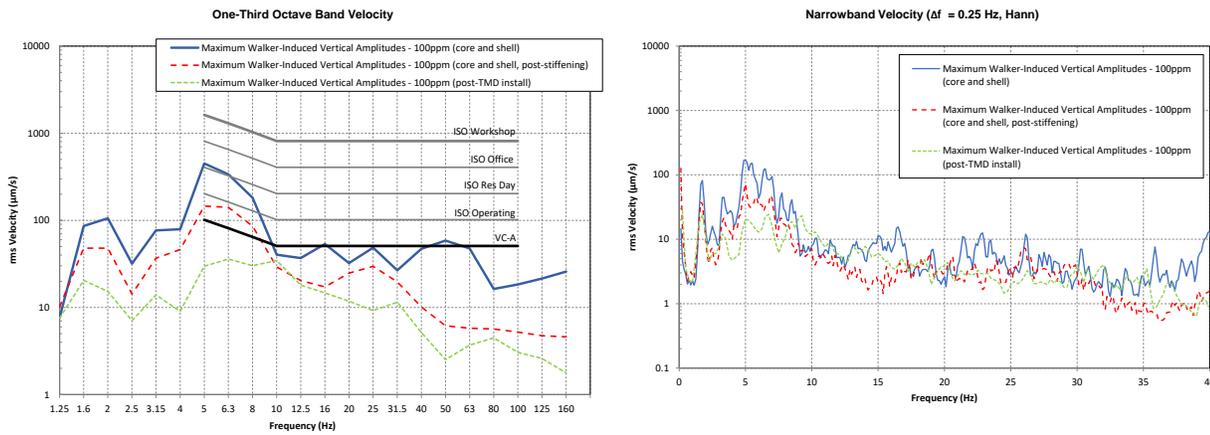
Figure 15: Case 6 – Measured walker-induced vibration amplitudes in a representative bay throughout vibration mitigation installation.

Walker-induced vibration amplitudes in a representative retrofitted bay are shown in Figure 15 under three separate conditions: core and shell, core and shell plus steel retrofits and partitions installed, and final fit-out with TMDs installed and operating. The results show that the structural steel retrofits significantly reduce the walker-induced vibration amplitudes – by around 2x (6 dB). The introduction of the TMD reduces the amplitudes further, to the point that the VC-A criterion is met. The narrowband FFT spectra show that the effect of the TMD is most pronounced around the resonance frequency of the bay, as expected. Some reduction in the amplitudes at other frequencies is evident as well, which could be due to the added mass of the TMD and/or added damping from further fit-out installed between the post-retrofit measurements and post-TMD measurements. The results show that the combination of added steel, TMDs, and damping from fit out were sufficient to achieve the project criteria.
